Boundary of UNISMU site
Approx 25 ha
Purchased from previous Taiwanese aquaculture company

UNISMU want to operate four contiguous ponds into the future.

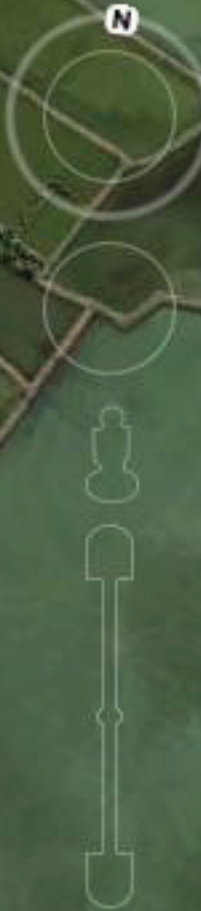
The village and local government keep trying to plant this eroding shore.

They've done it and failed 4 times now.

Seldom inundated

Typical back mangal species; *L. racemosa*, *C. tagal*, *A. ilicifolius*, *P. acidula*

Somewhat natural looking drainage creek with mix of lower, mid and upper mangrove plants; relatively high diversity

R. mucronata dominant, with *A. marina* at lowest elevations
lowest *A. marina* seedling = 66 cm Avg low *A. marina* seedling = 82.8 cm (n=6)
lowest *R. mucronata* seedling = ? Avg low *R. mucronata* seedling = ?

Pond bottom measured at 54cm above LGT

S. alba dominant - with some *R. mucronata*, *R. apiculata* and *A. marina*
lowest *S. alba* = 67 cm above LGT Avg low *S. alba* seedling = 78.6 (n=8)

S. alba seedlings abundant on sides of ponds (2000/ha density)
ponds empty in the middle at lower substrate elevation
